## **DRAFT ENVIRONMENTAL IMPACT STATEMENT FOR A MINED LAND USE PLAN MODIFICATION**

**COUNTY LINE STONE CO., INC.  
AKRON QUARRY  
AKRON, NEW YORK**

## **VOLUME 5**

**Groundwater Data**

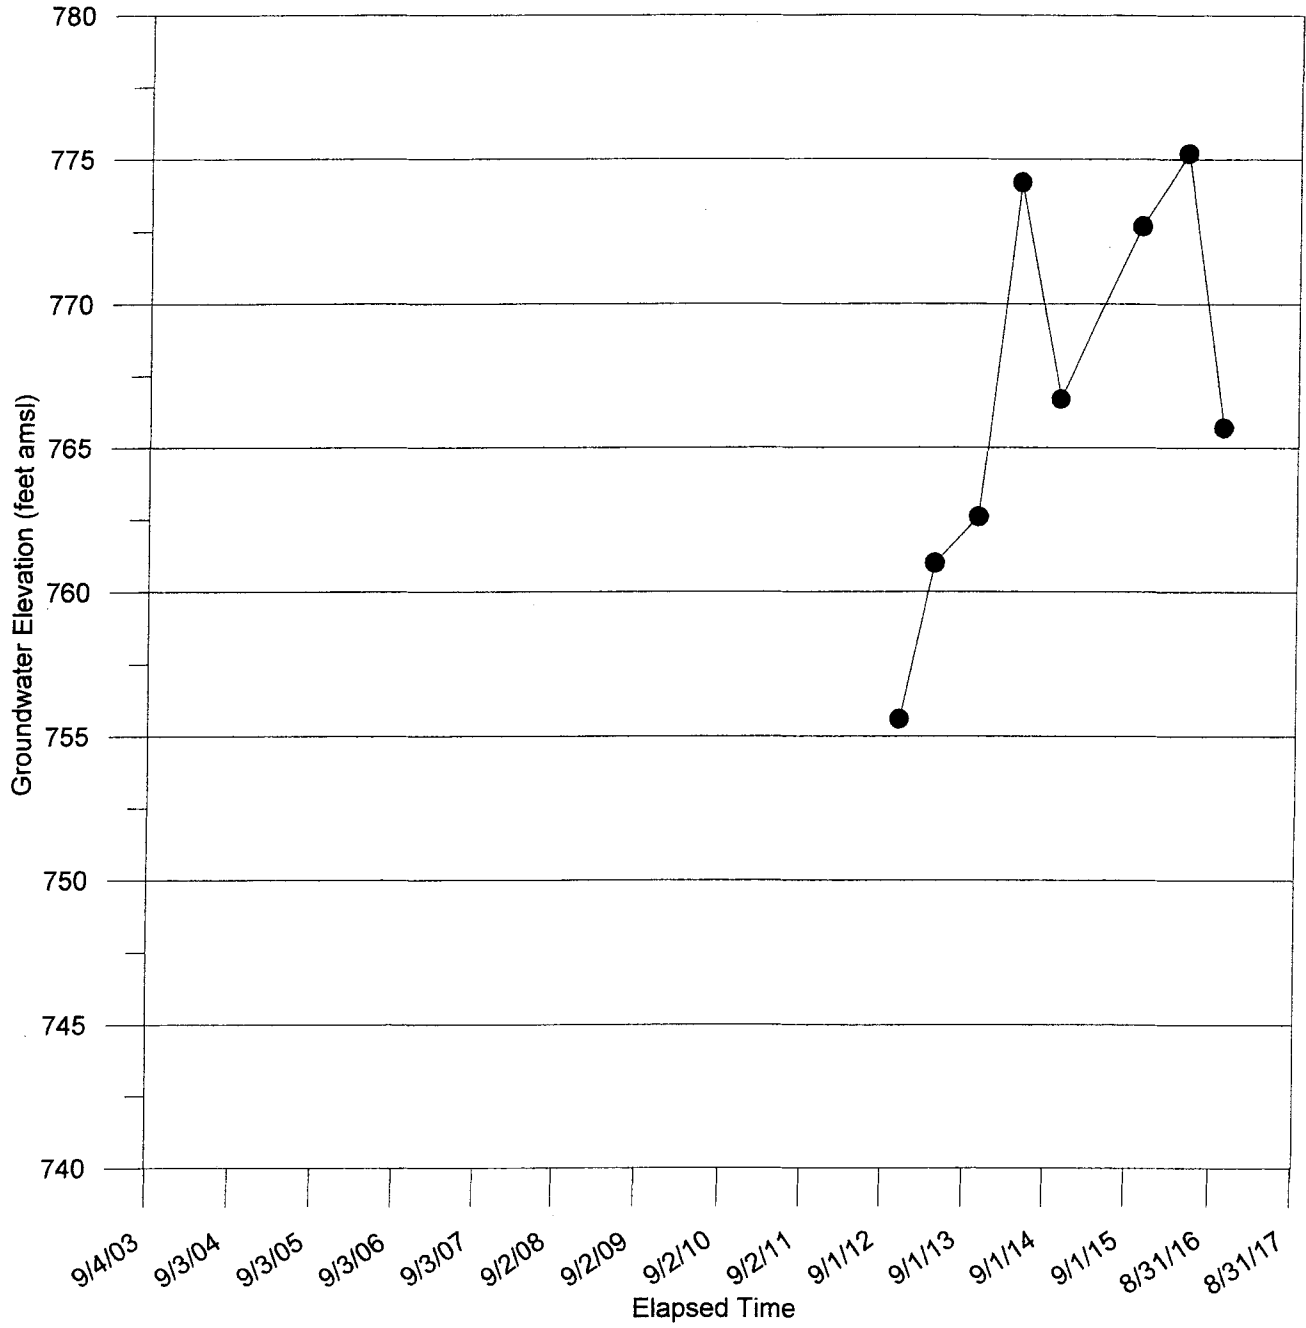
**Groundwater Elevations  
Well 4-12  
Corfu, NY  
County Line Stone Co., Inc.**

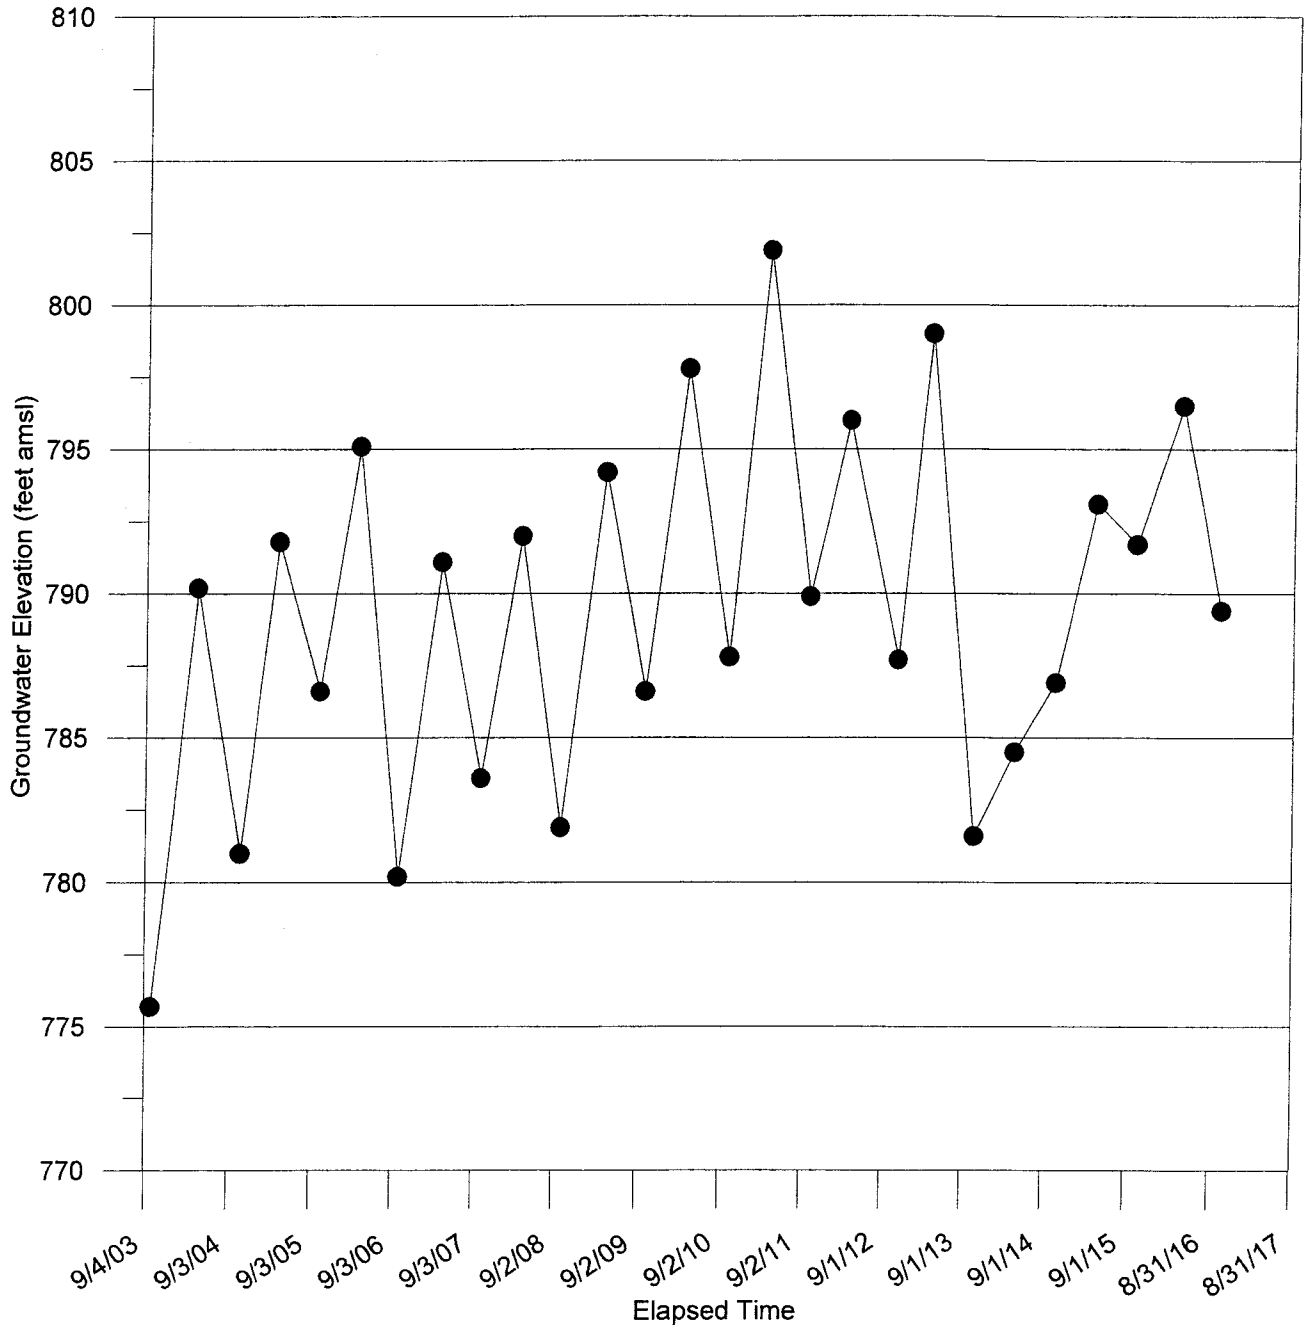
**Groundwater Elevations**  
**283 Cohocton Road**  
**Corfu, NY**  
**County Line Stone Co., Inc.**

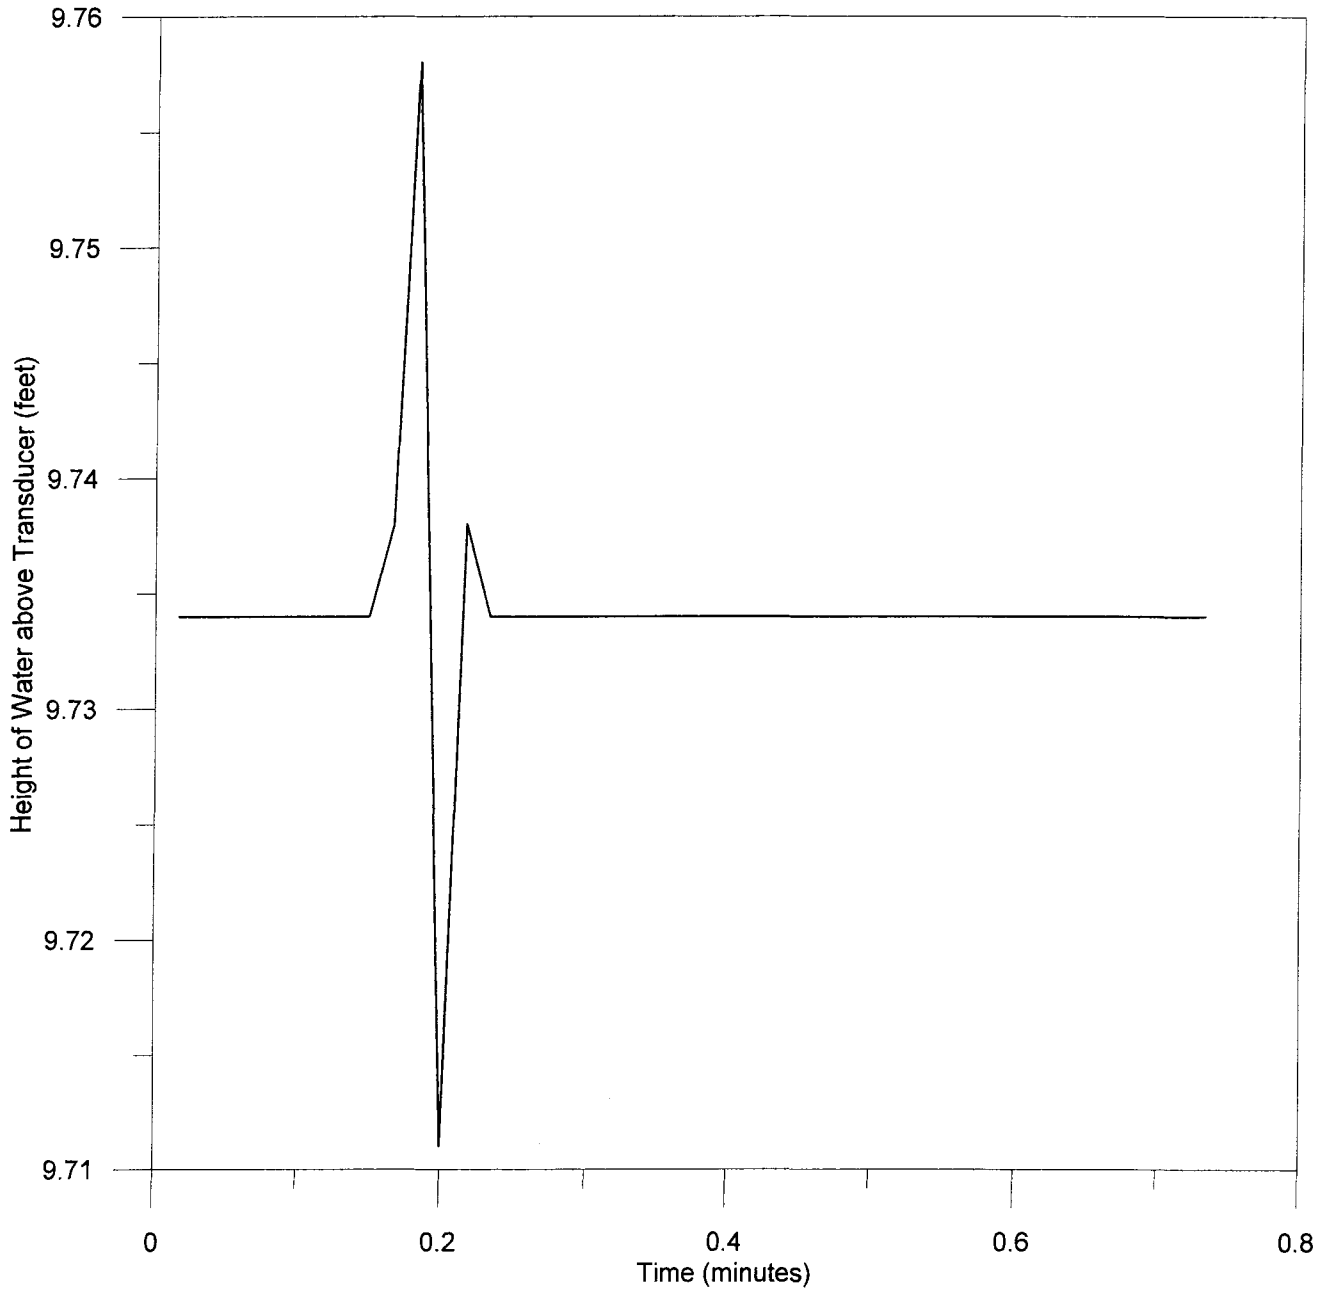
**Figure A-1**  
**Falling Head Slug Test 1 in 1-12 Corehole**  
**Akron Quarry**  
**County Line Stone Company, Inc.**

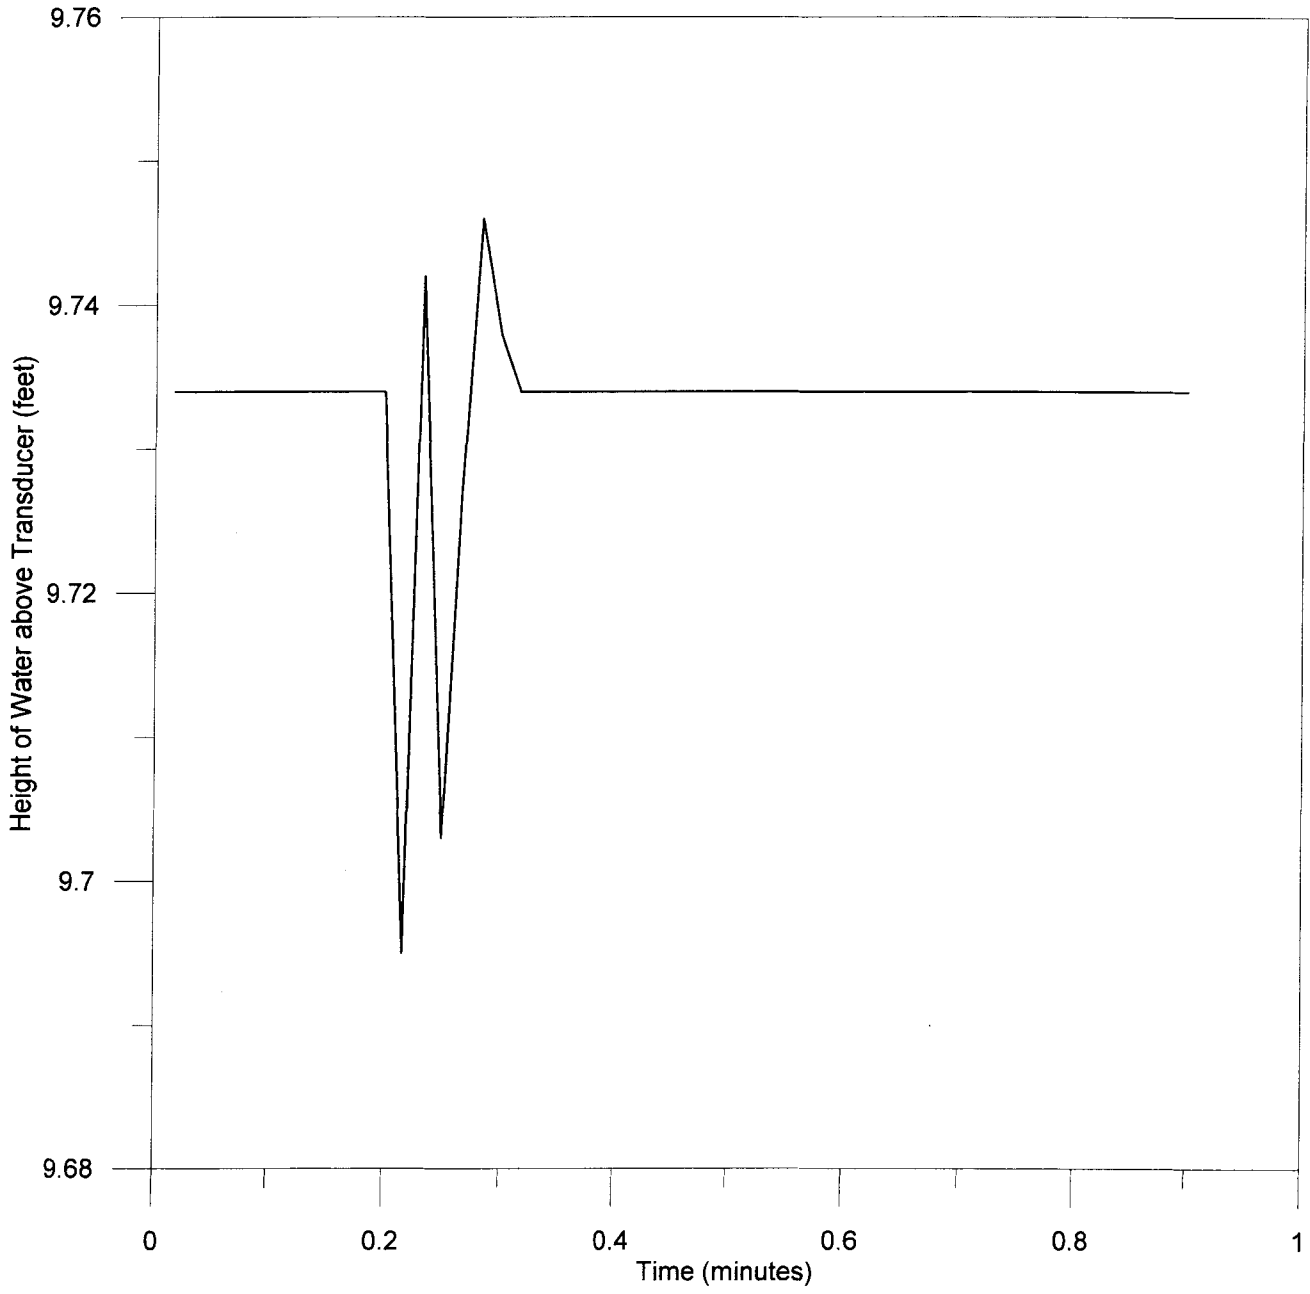
**Figure A-2**  
**Rising Head Slug Test 1 in 1-12 Corehole**  
**Akron Quarry**  
**County Line Stone Company, Inc.**

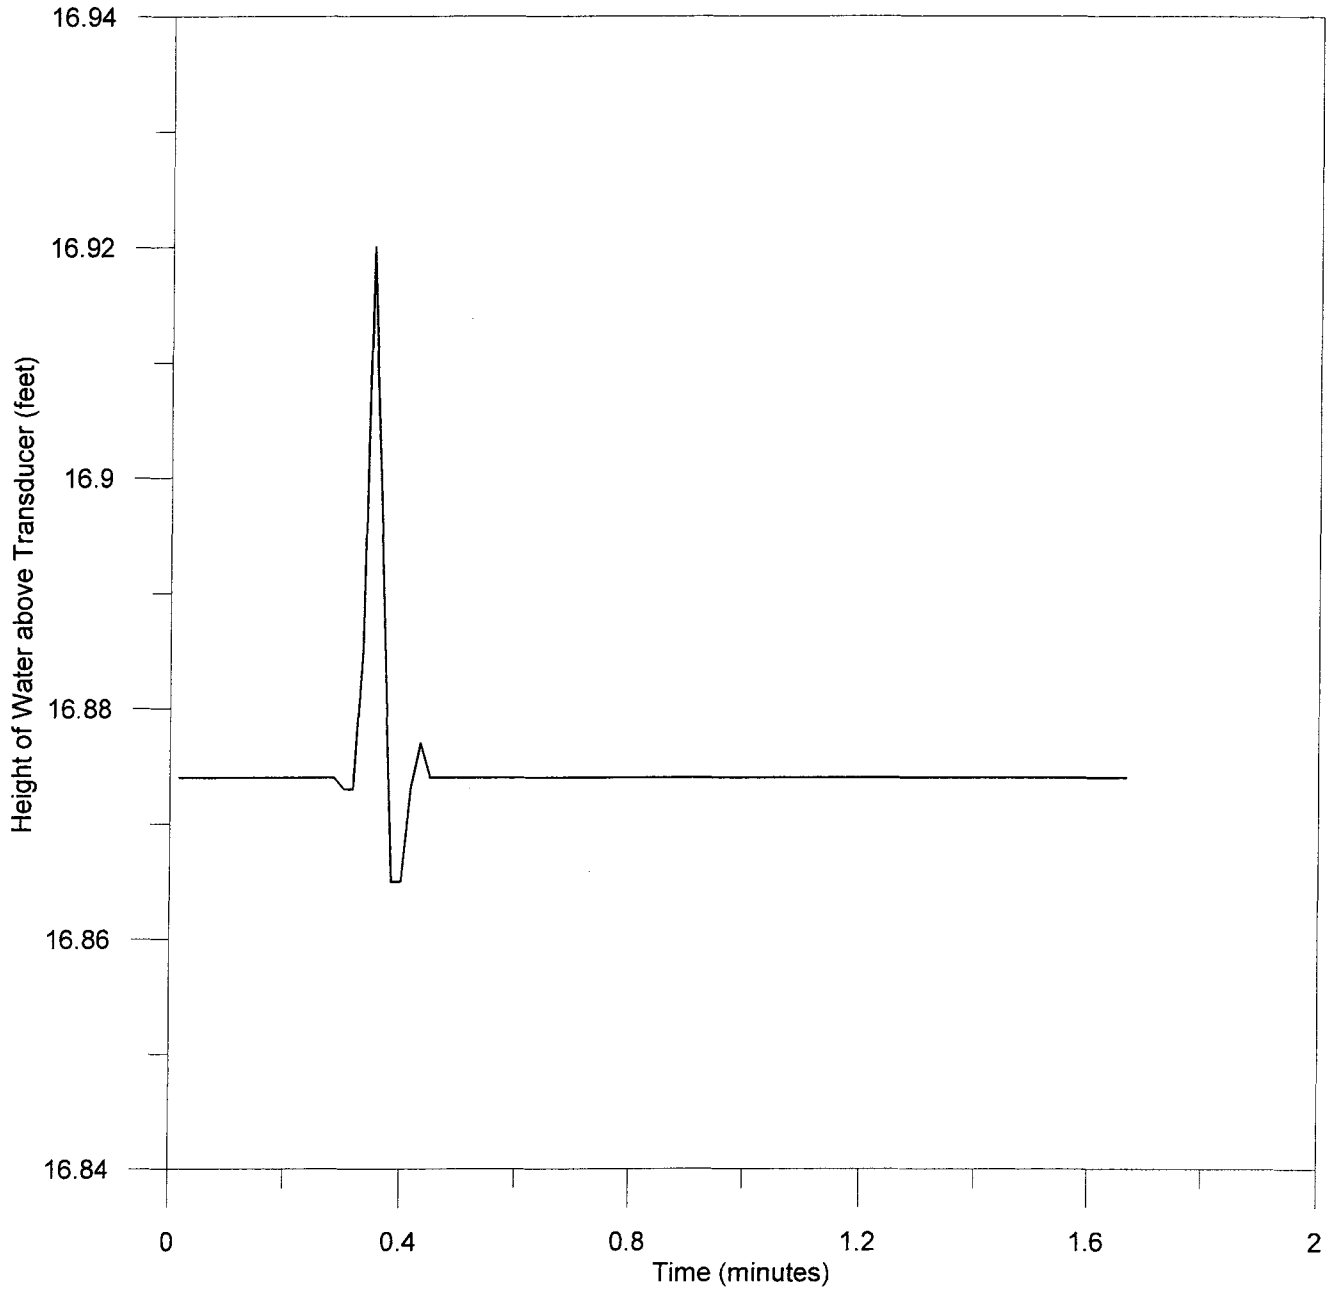
**Figure A-3**  
**Falling Head Slug Test 2 in 1-12 Corehole**  
**Akron Quarry**  
**County Line Stone Company, Inc.**

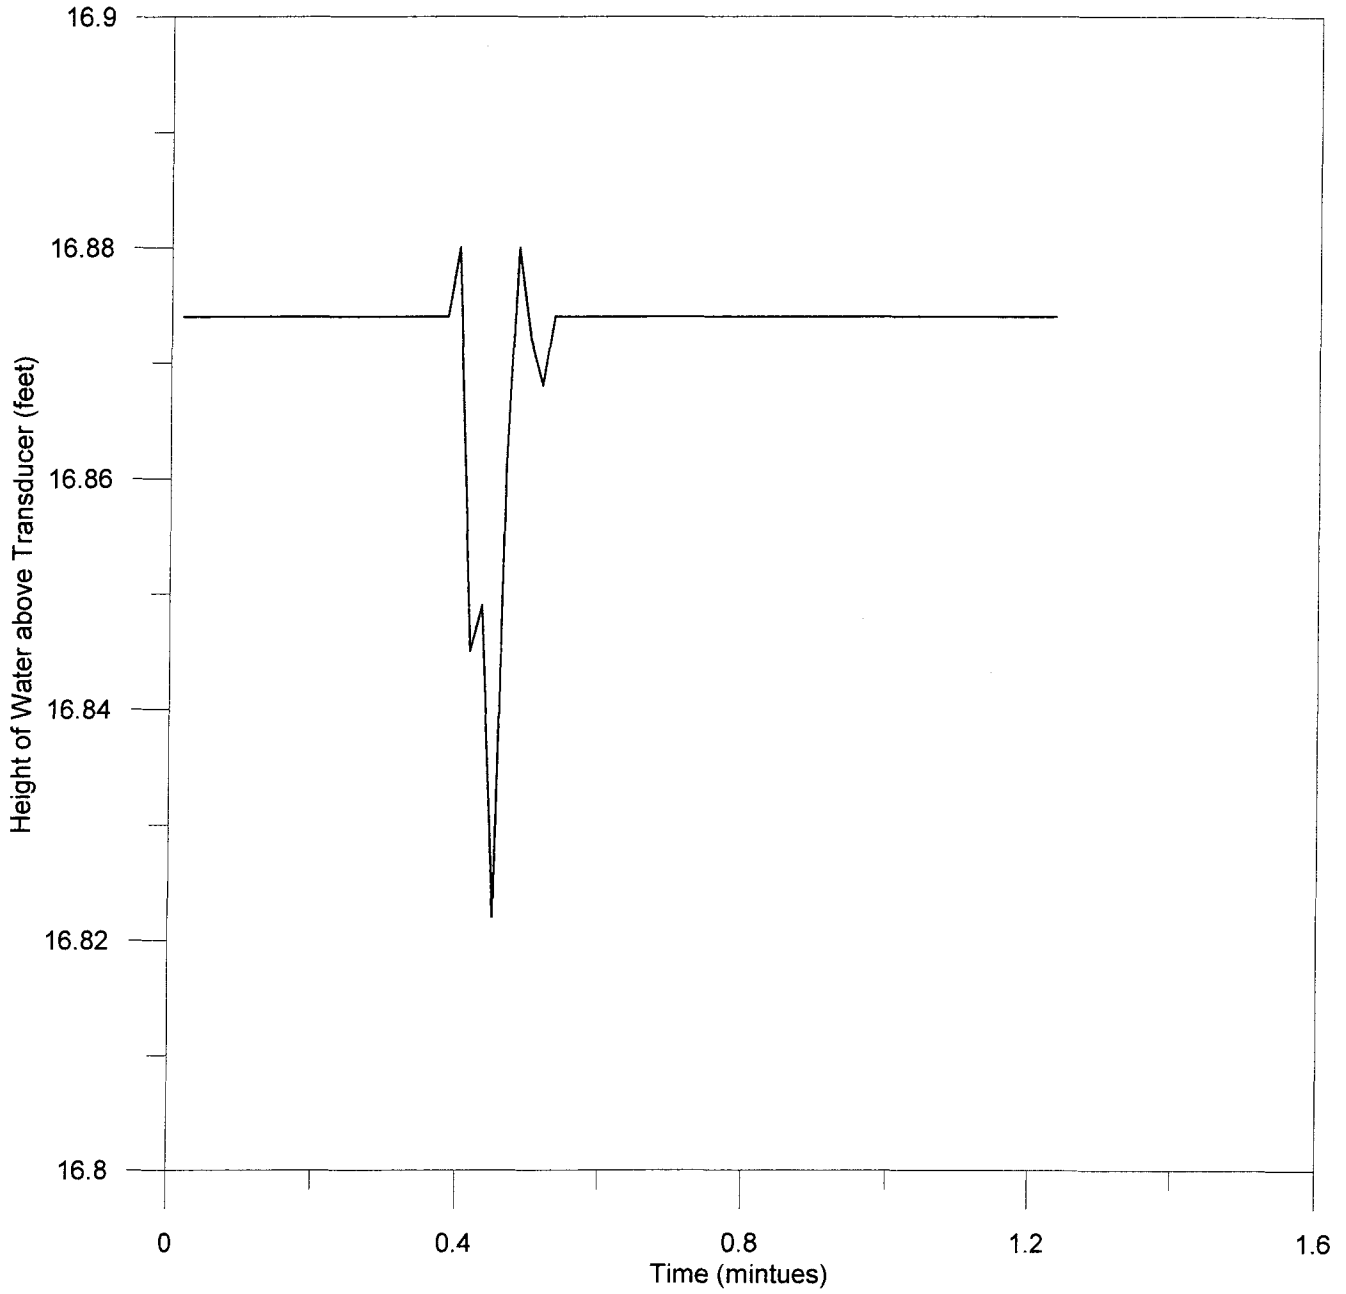
**Figure A-4**  
**Rising Head Slug Test 2 in 1-12 Corehole**  
**Akron Quarry**  
**County Line Stone Company, Inc.**

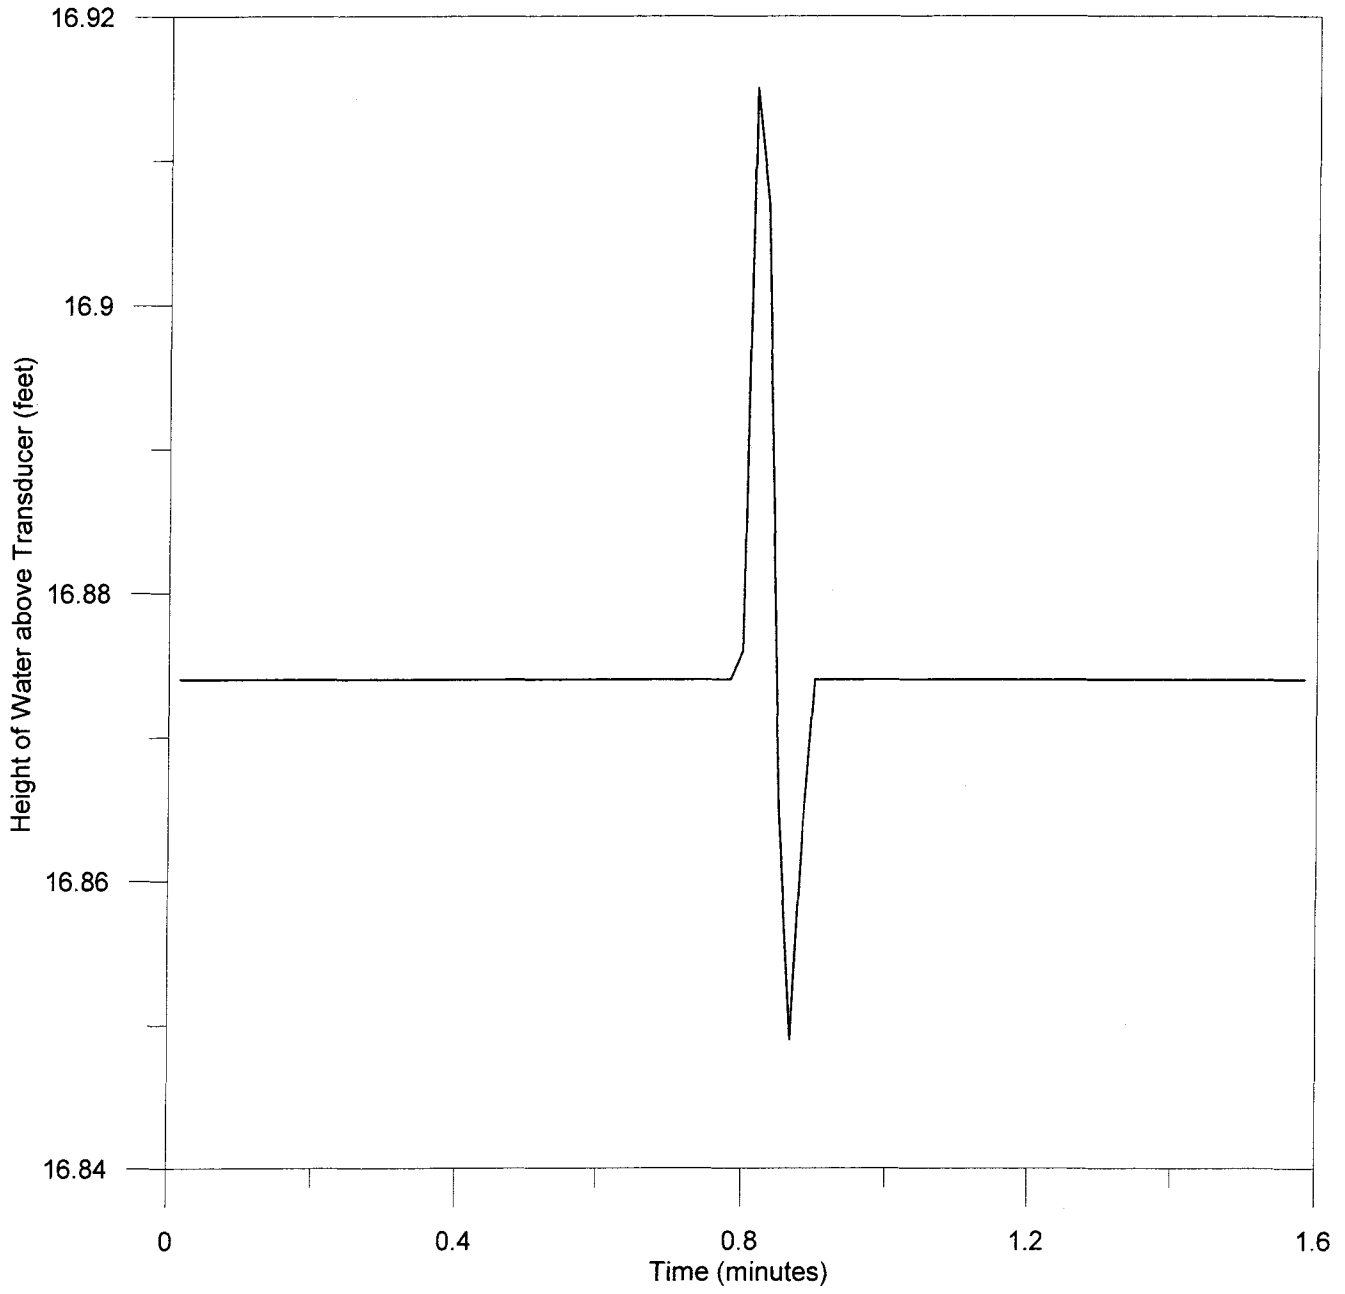
**Figure A-5**  
**Falling Head Slug Test 3 in 1-12 Corehole**  
**Akron Quarry**  
**County Line Stone Company, Inc.**

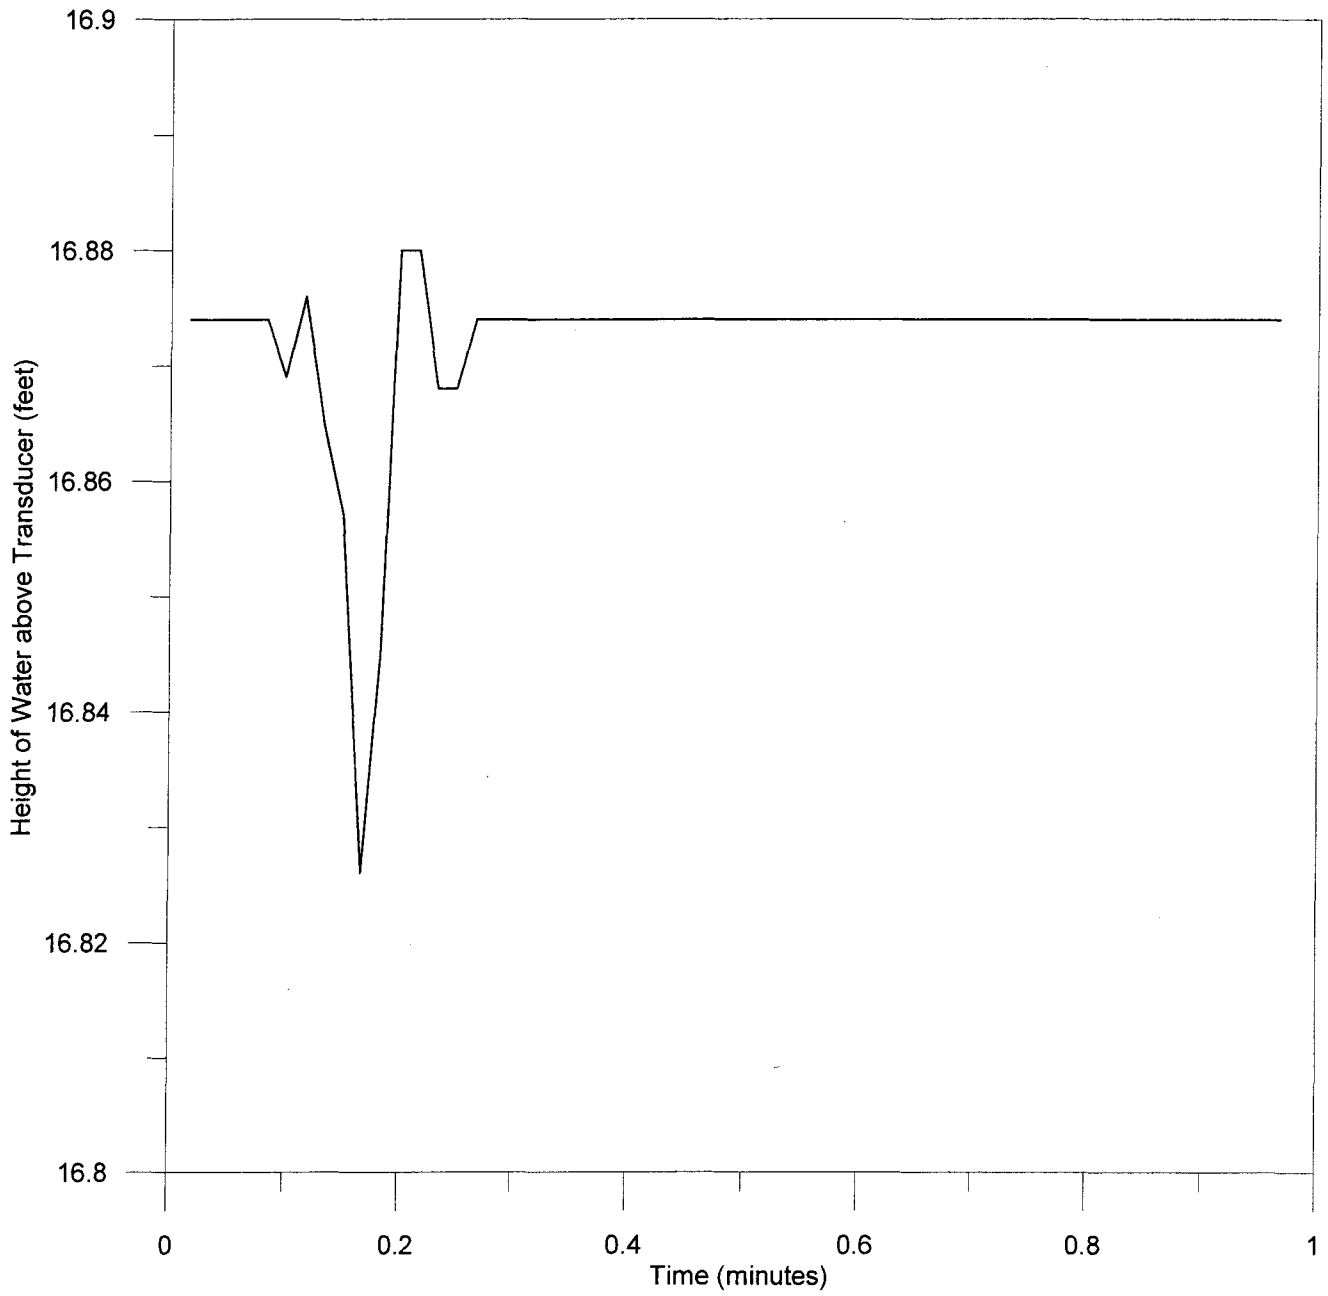
**Figure A-6**  
**Rising Head Slug Test 3 in 1-12 Corehole**  
**Akron Quarry**  
**County Line Stone Company, Inc.**

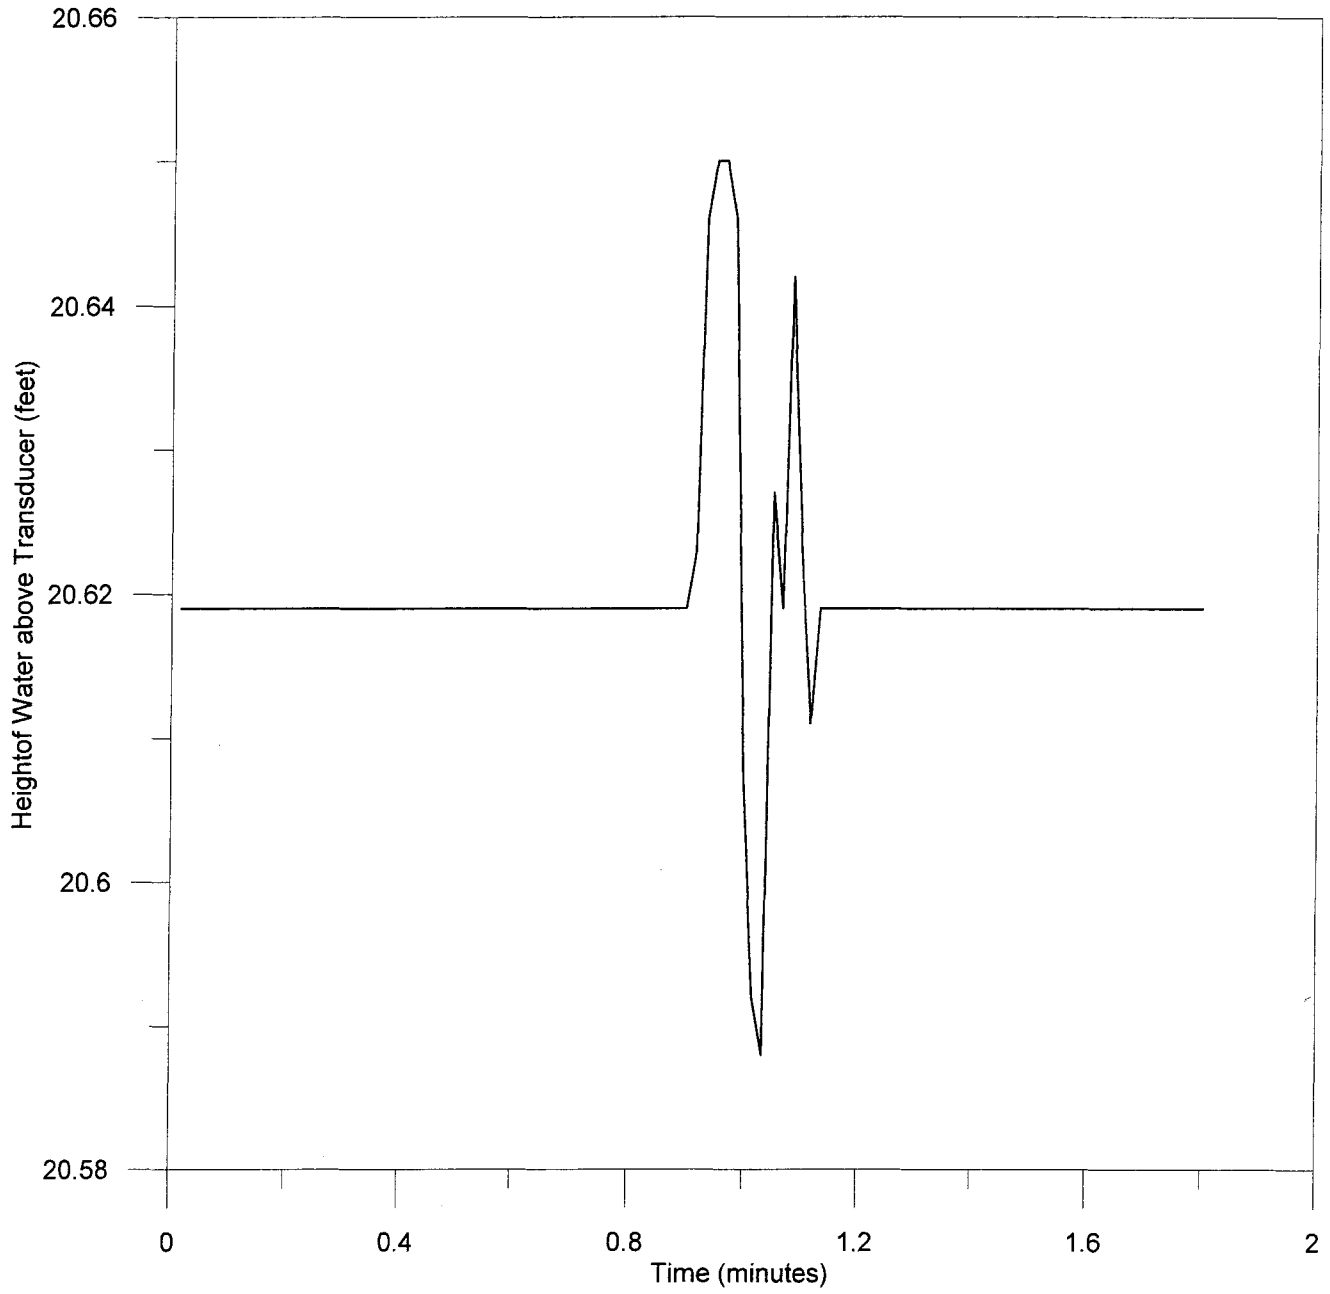
**Figure A-7**  
**Falling Head Slug Test 1 in 2-12 Corehole**  
**Akron Quarry**  
**County Line Stone Company, Inc.**

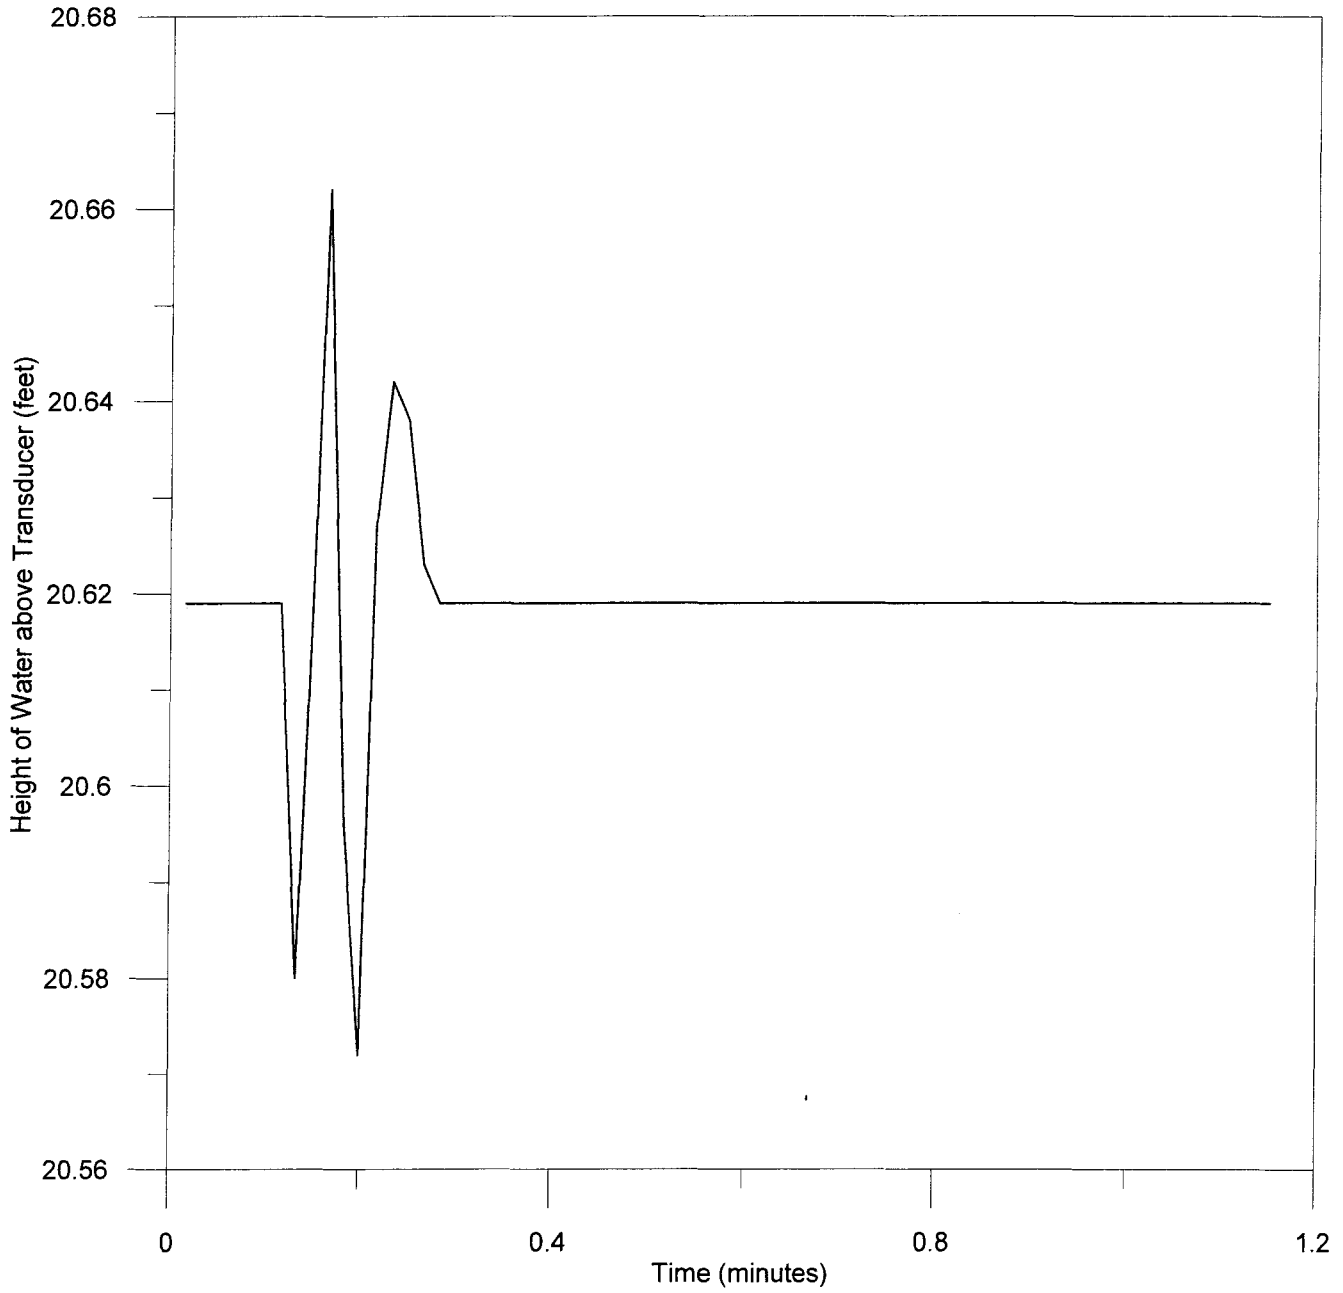
**Figure A-8**  
**Rising Head Slug Test 1 in 2-12 Corehole**  
**Akron Quarry**  
**County Line Stone Company, Inc.**

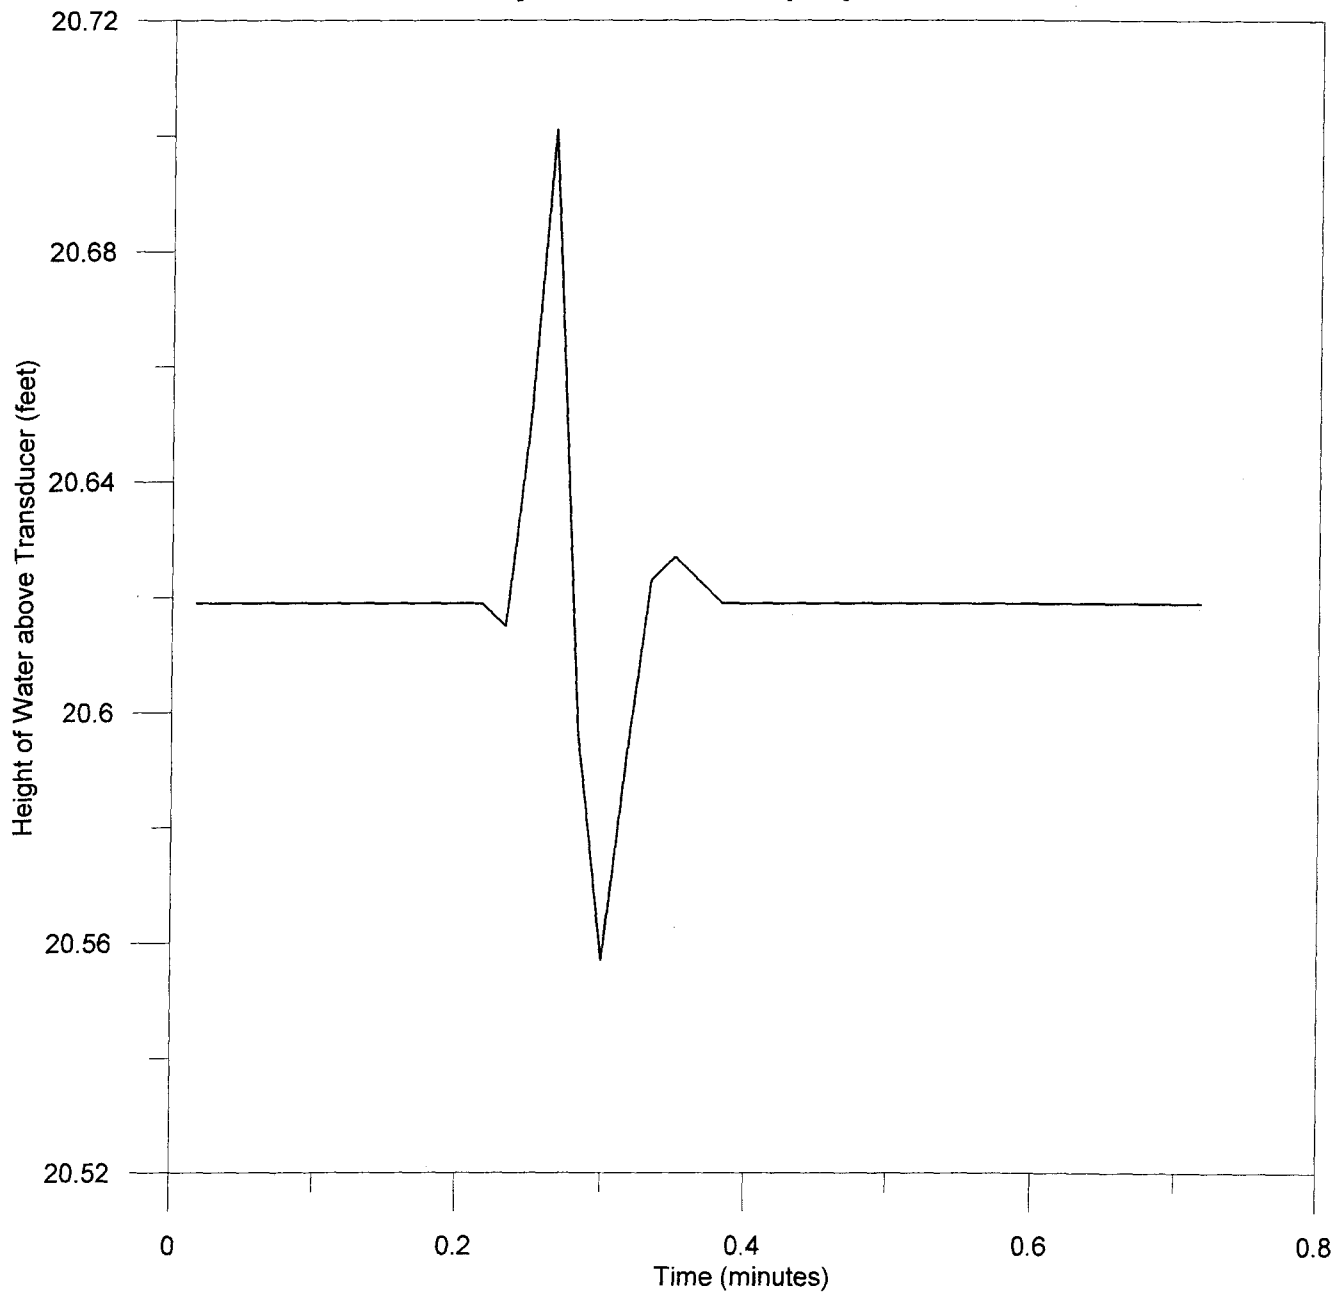
**Figure A-9**  
**Falling Head Slug Test 2 in 2-12 Corehole**  
**Akron Quarry**  
**County Line Stone Company, Inc.**

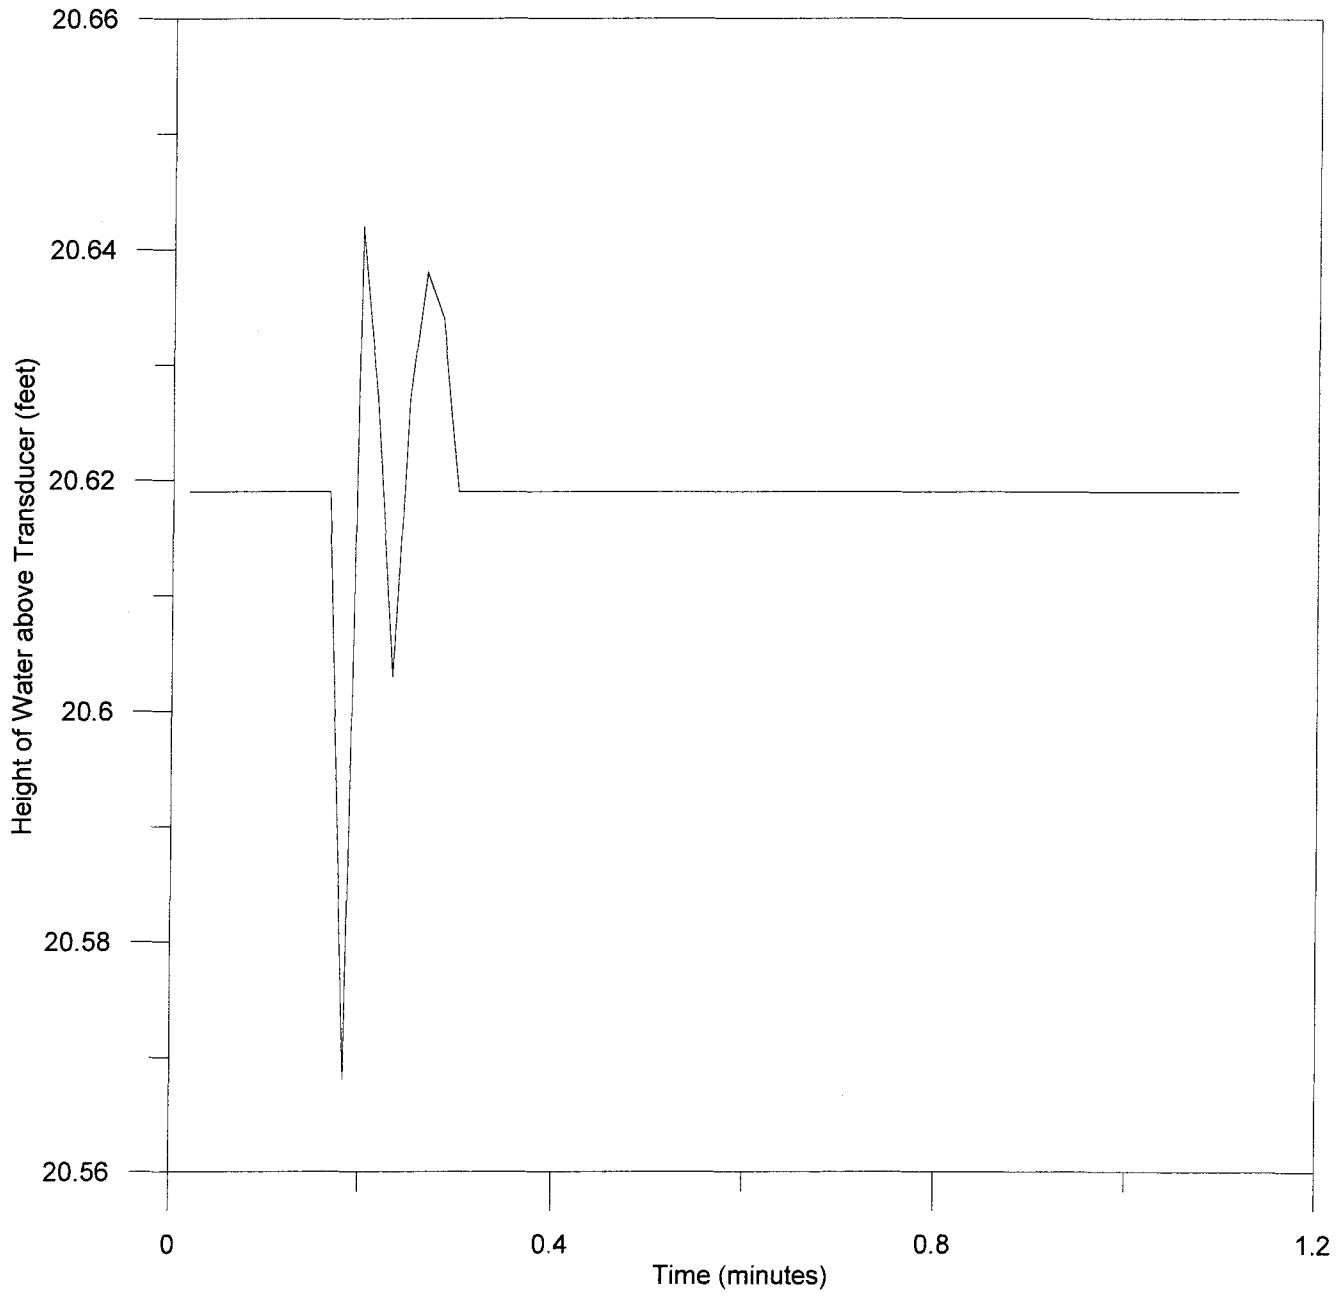
**Figure A-10**  
**Rising Head Slug Test 2 in 2-12 Corehole**  
**Akron Quarry**  
**County Line Stone Company, Inc.**

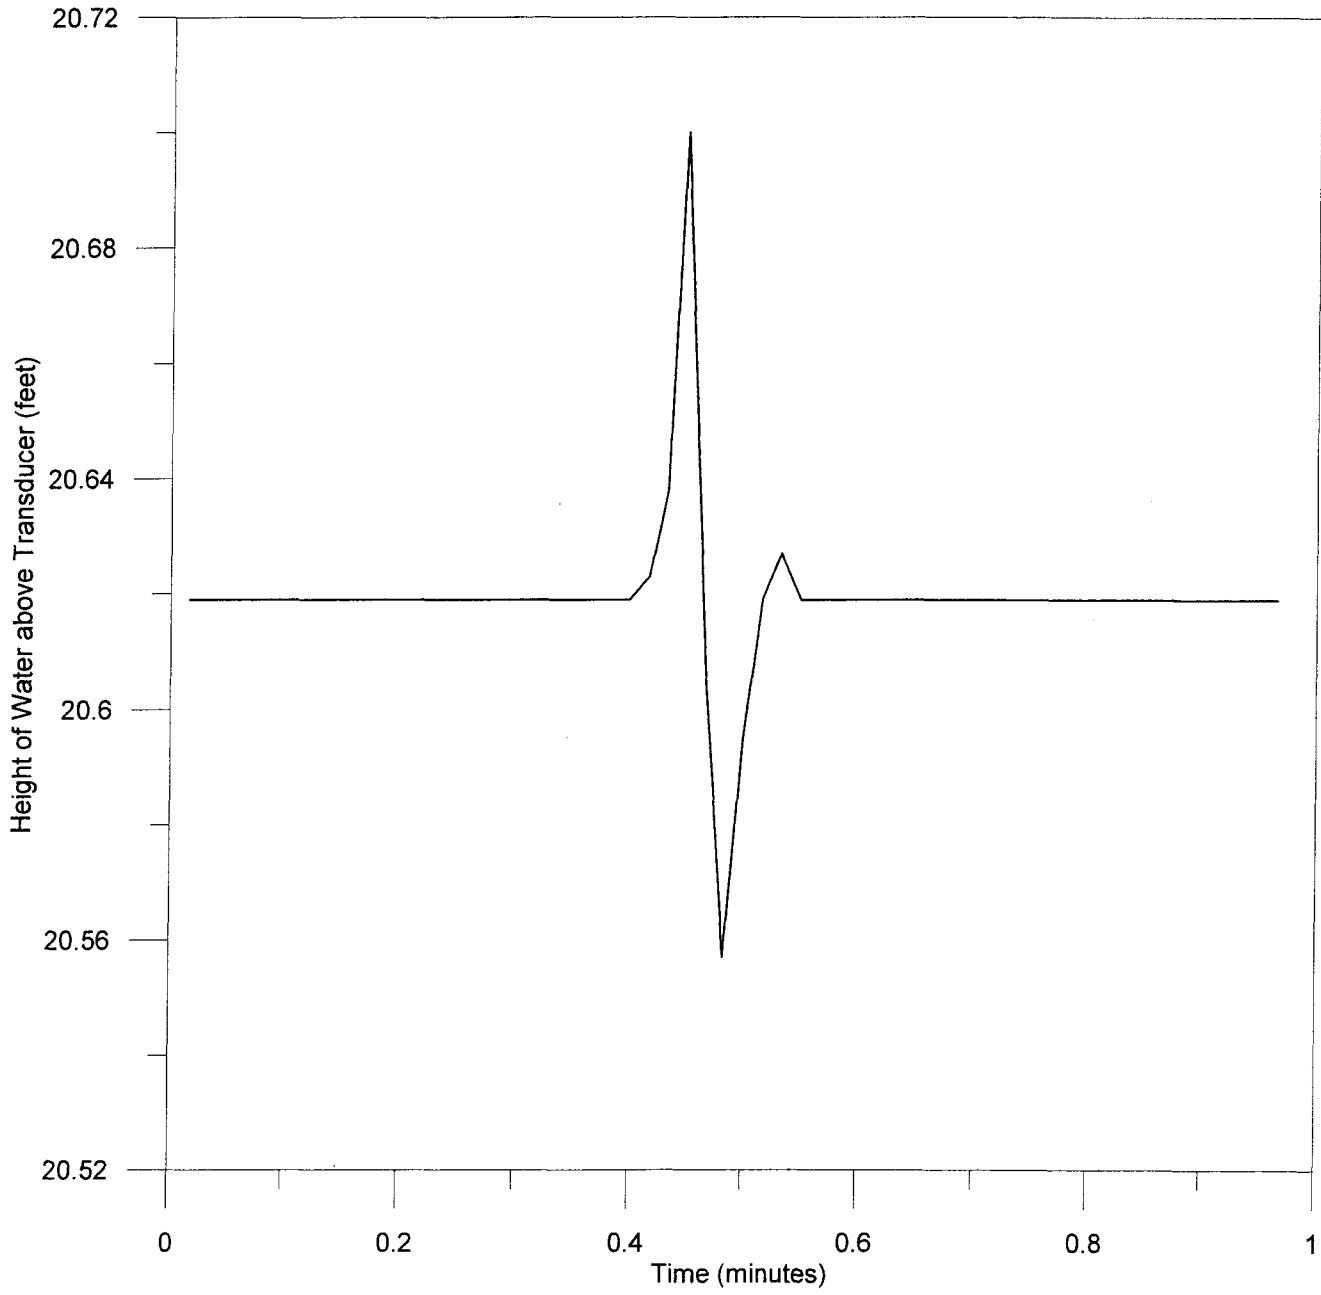
**Figure A-11**  
**Falling Head Slug Test 3 in 2-12 Corehole**  
**Akron Quarry**  
**County Line Stone Company, Inc.**
