## **DRAFT ENVIRONMENTAL IMPACT STATEMENT FOR A MINED LAND USE PLAN MODIFICATION**

**COUNTY LINE STONE CO., INC.  
AKRON QUARRY  
AKRON, NEW YORK**

## **VOLUME 5**

**Groundwater Data**

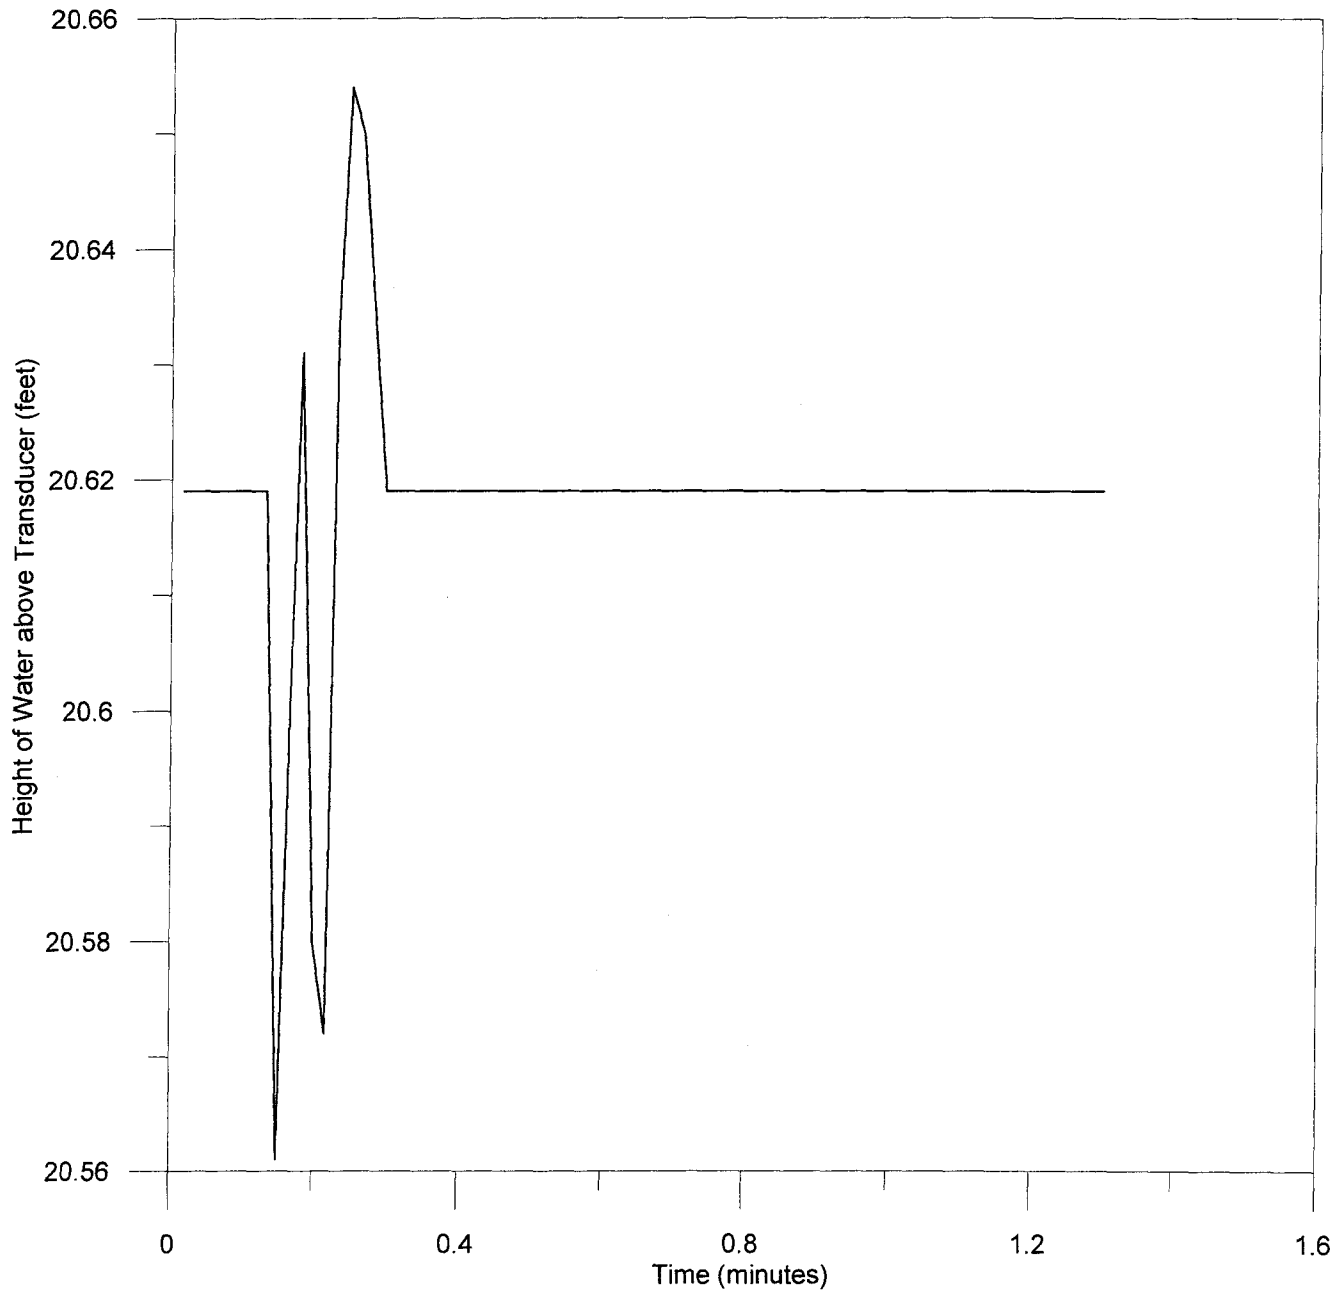
**Figure A-12**  
**Rising Head Slug Test 3 in 2-12 Corehole**  
**Akron Quarry**  
**County Line Stone Company, Inc.**
